First United Methodist Church  
Clarinda, Iowa

Facilities Improvement Committee  
Congregational Forum & Progress Update  
to Congregation, November 14, 2010

- Walk-thru evaluation conducted April 9, 2010 with Ron Tekippe and Dean Fajen, licensed Engineers from HGM Associates Inc. – Consultant, Council Bluffs, Iowa.
- Purpose: To obtain an un-biased viewpoint that would identify concern areas within the existing Church; to gather information useful for either renovating the existing Church or building a new Church.

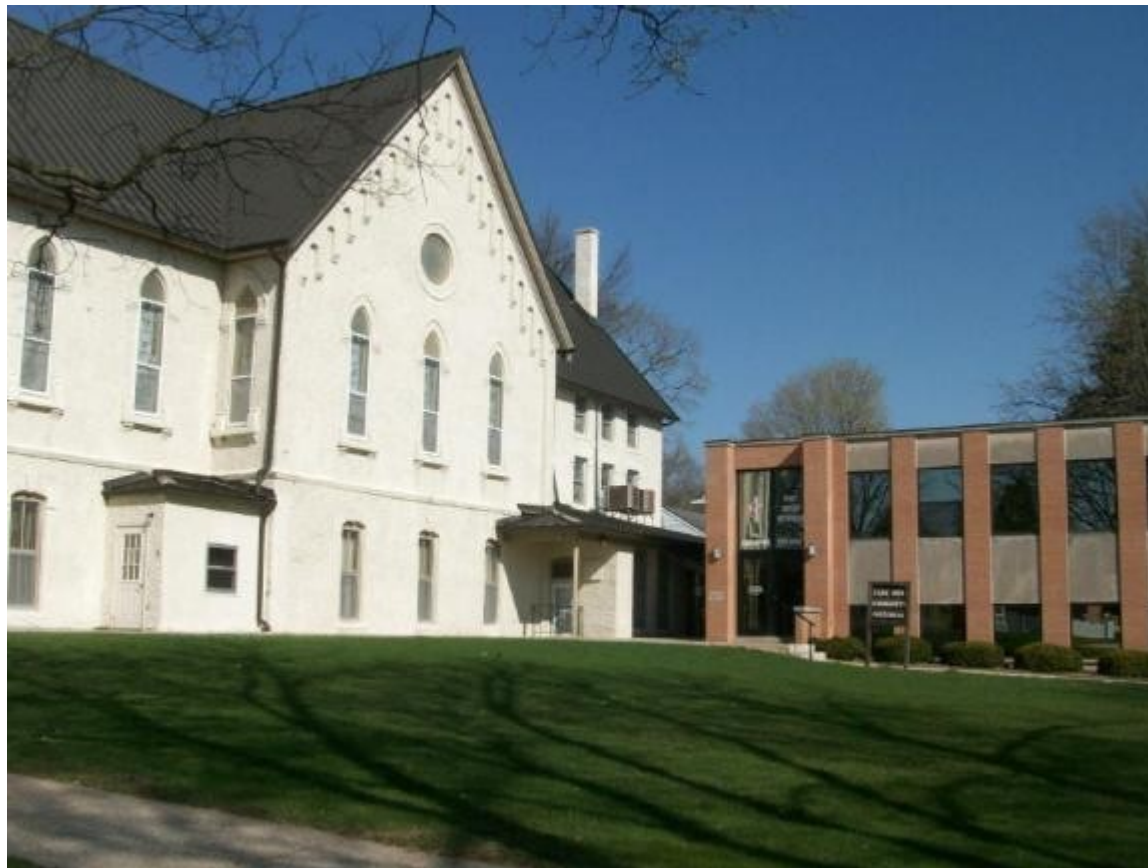
*Photo #2*

*Intersection Of Church And Educational Building*

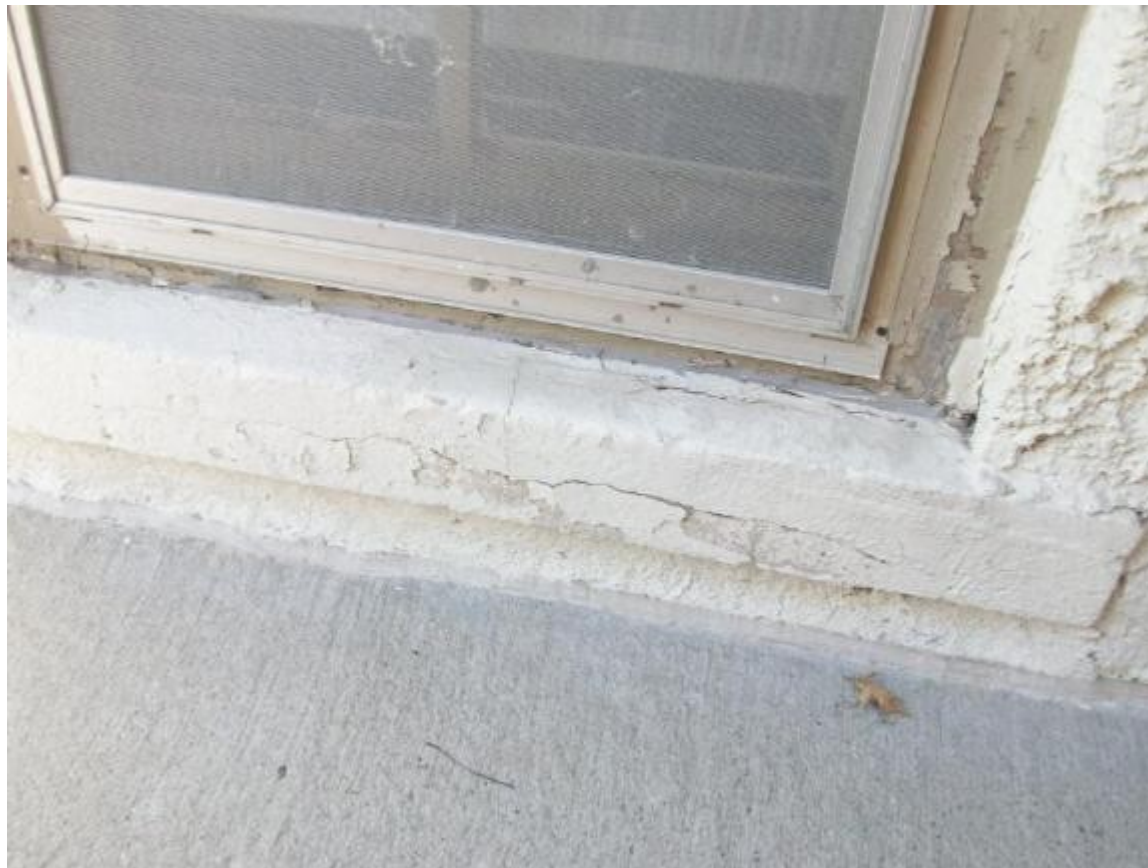
Photo #3

Deteriorated Windows And Stucco Coating

- Existing Church:
  - A new casket-sized elevator should be installed allowing access to all the levels of the existing Church.
  - An addition could be incorporated also allowing handicap accessibility to the adjacent educational building.
  - Address handicap issues (i.e. restrooms, accessibility to restrooms on both the lower and Sanctuary levels).
  - Address HVAC issues for better efficiency and minimization of mold conditions.
  - Safety and Code concerns: fire sprinkler and fire alarm should be installed.
  - Stucco: should be removed and the underlying brick replaced and repaired.

- Existing Church:
  - A new Pastor's Office and Administrative Offices should be constructed at a location for convenient access and handicap accessibility.
  - Counseling areas and Conference Rooms should be included with appropriate office work areas.
  - Replace all deteriorated, inefficient windows.

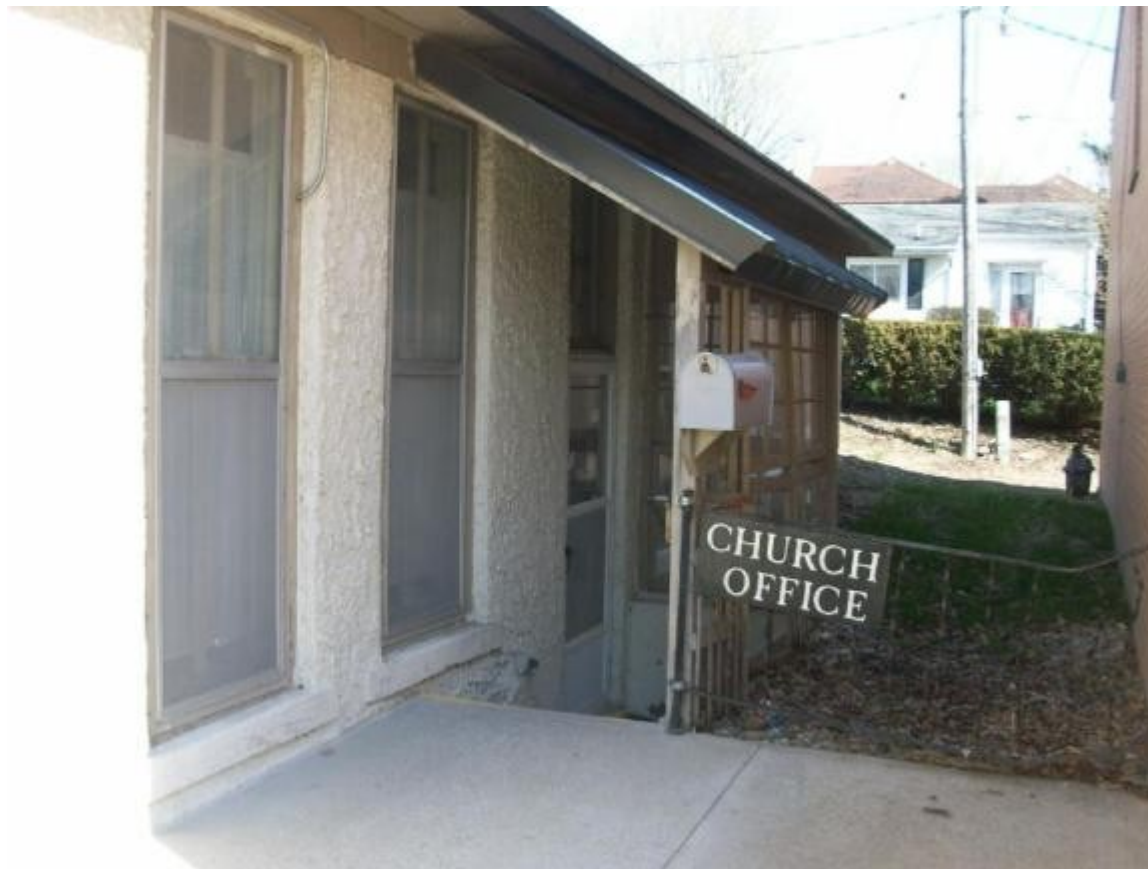
Photo #4

- Handicap accessible restrooms do not exist, no restrooms on main level.
- Pastor's office is difficult to locate visually and impossible for handicap people to access.
  - Visitors have difficulty identifying the office area.
- No private counseling areas available and only one means of limited access to general office.
- General control and visibility of the Church site from the office area is non-existent.
- Kitchen is maintained well, but old and out of date and not code compliant.
- Cry Room – settlement may also have contributed to the unlevel floor condition.

Remote, Not Visible, Unfriendly, Not Handicapped  
Accessible Church Office

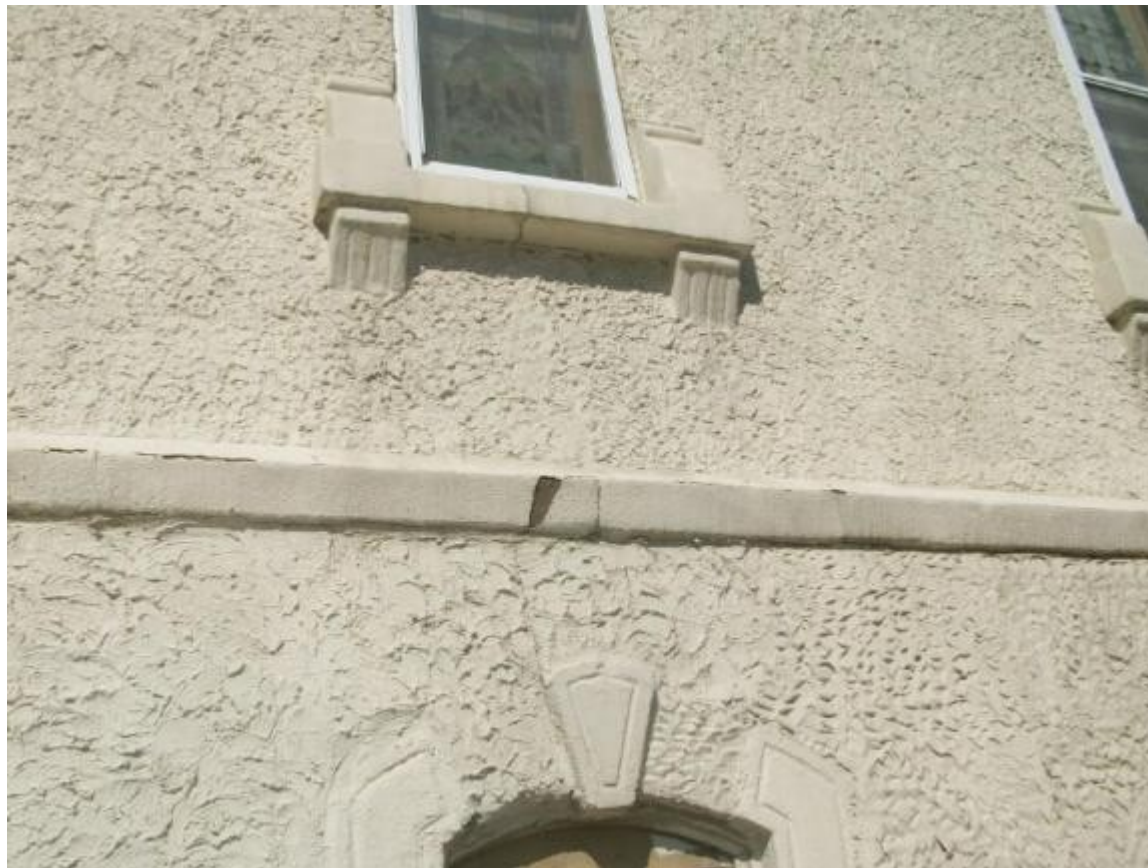
Photo #5

Stucco Deterioration On Stone Ledge

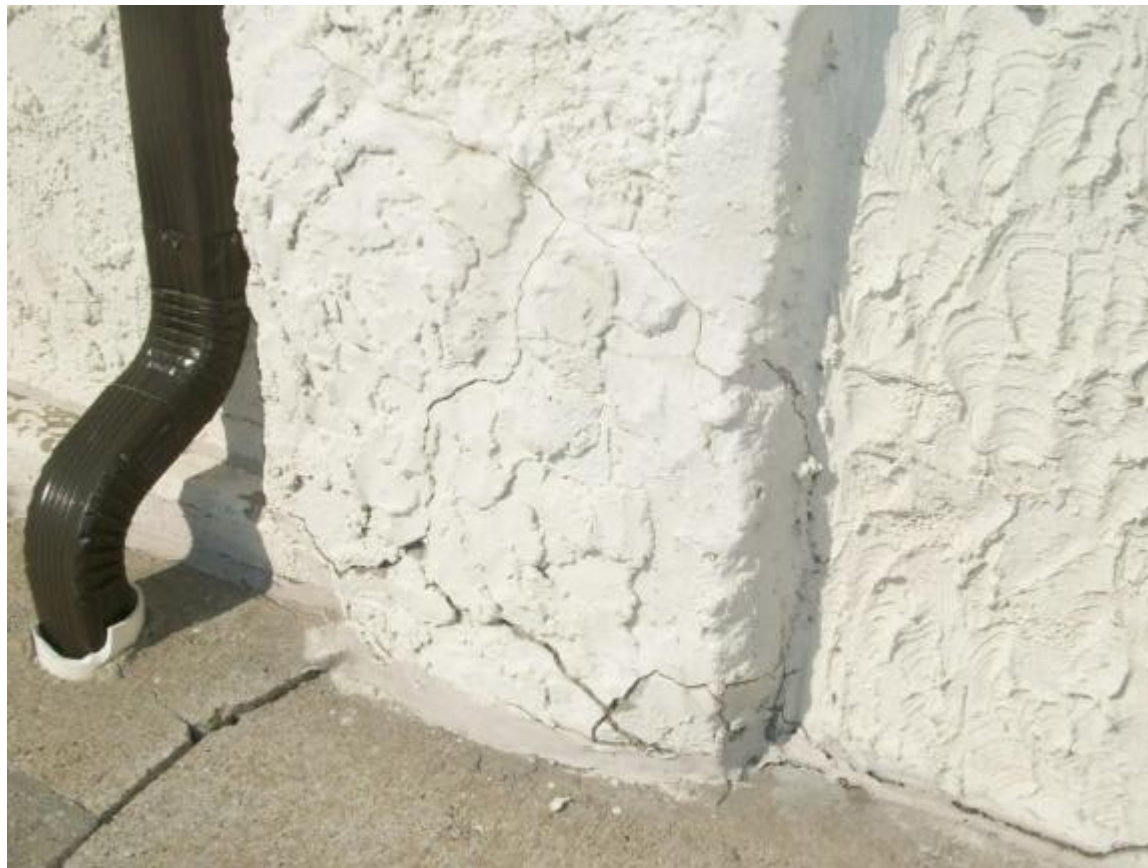
**Photo #6**

- Existing Church info:
  - Constructed in late 1800's
  - Addition added in 1940's
  - For its age, it is a relatively enduring structure.
  - Stucco was installed over the brick façade on the existing Church probably in an attempt to hide and address structural cracks and deteriorating mortar joints and brick.
  - Stucco at the present time is experiencing problems.
  - Numerous structural cracks evidenced throughout the structure.
  - Cracking situation allows moisture to migrate in behind stucco causing further deterioration.

**Cracks In Stucco Allowing Water Infiltration**

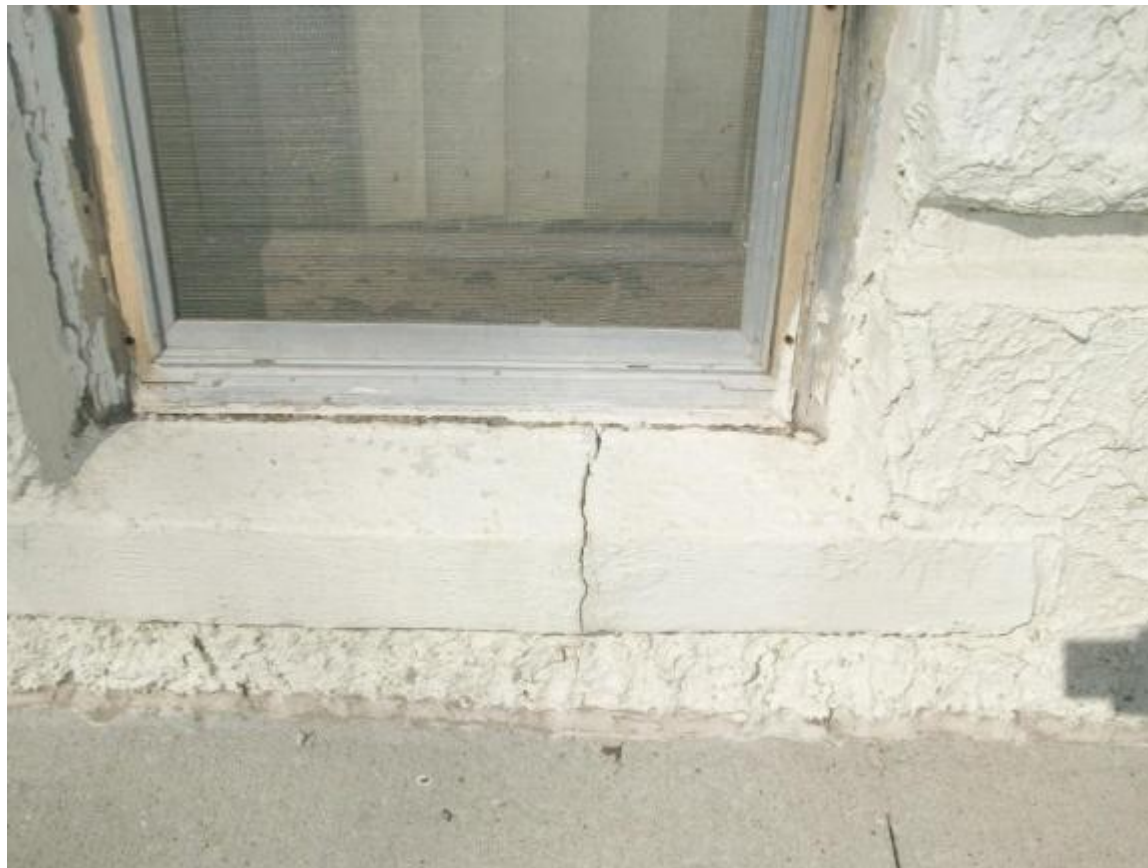
**Photo #7**

**Cracked Stone Sill, Stucco And Window Deterioration**

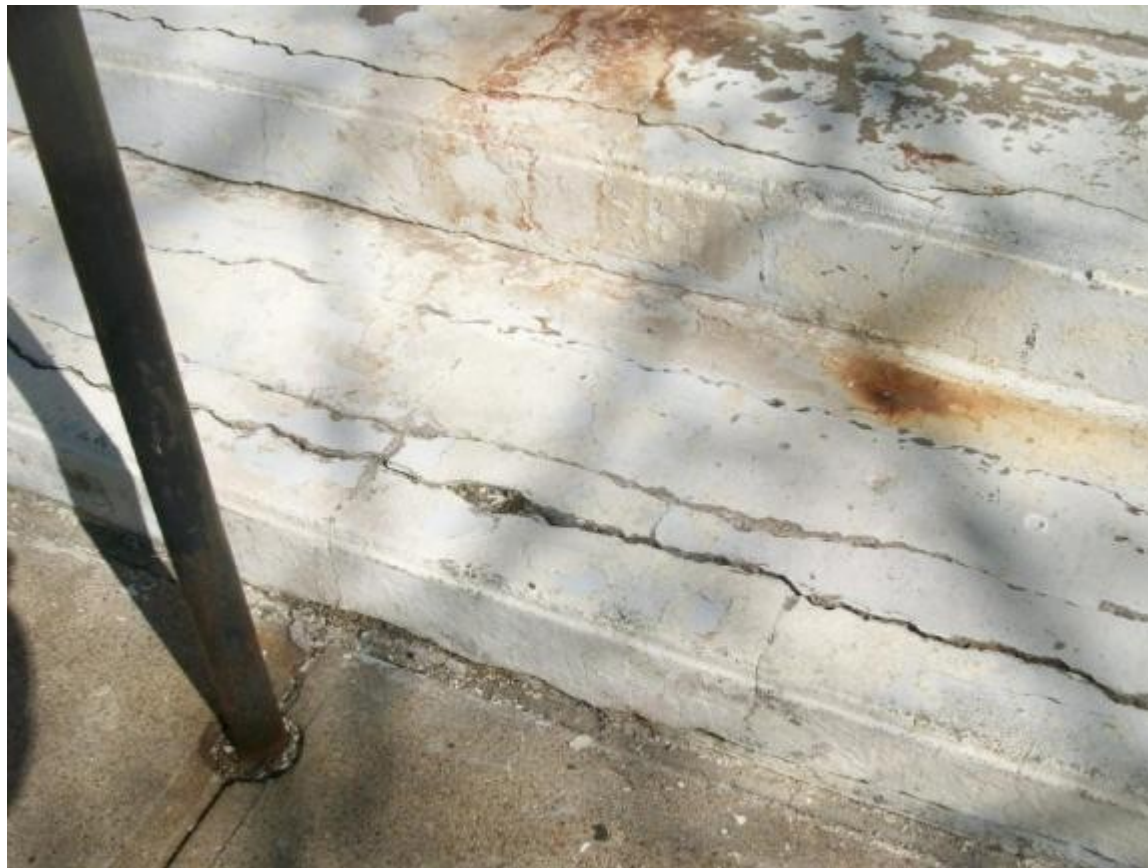
Photo #8

Masonry Deterioration

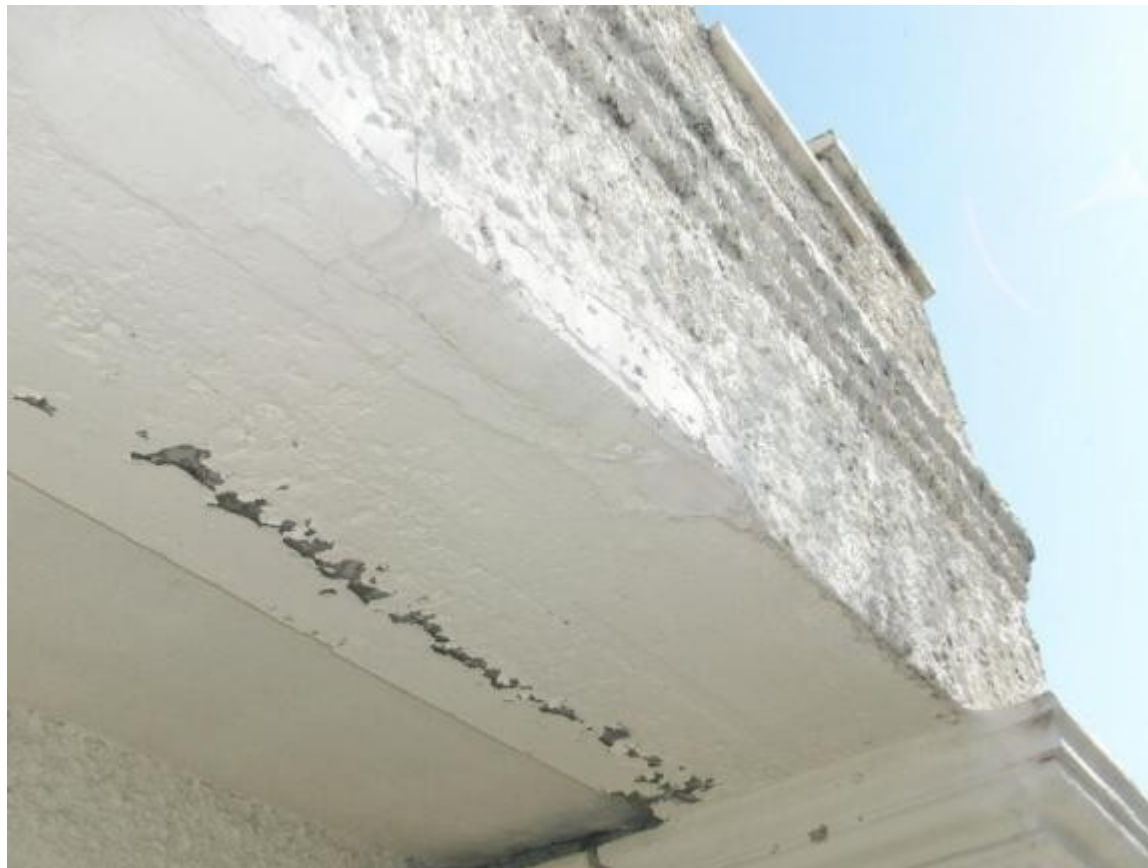
**Photo #9**

**Stucco Deterioration**

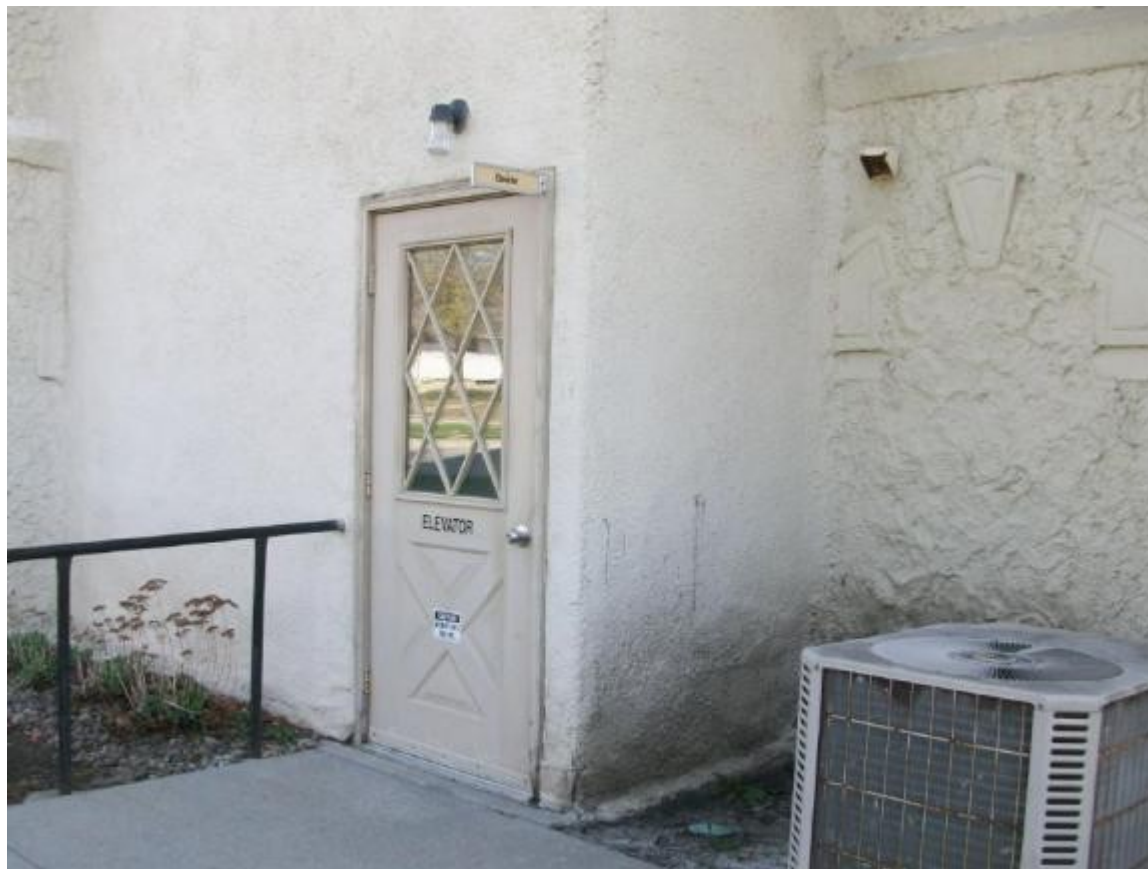
**Photo #10**

**Elevator Entrance**

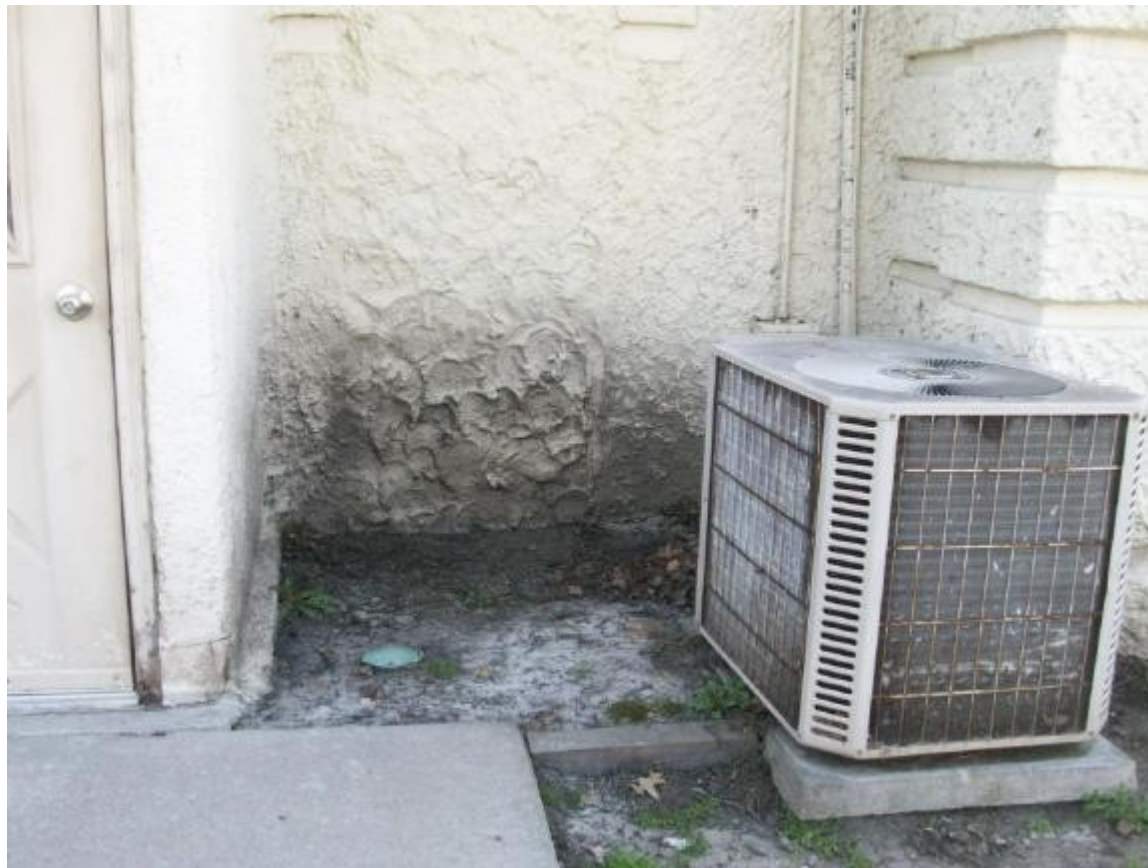
Photo #11

Mold Evidence

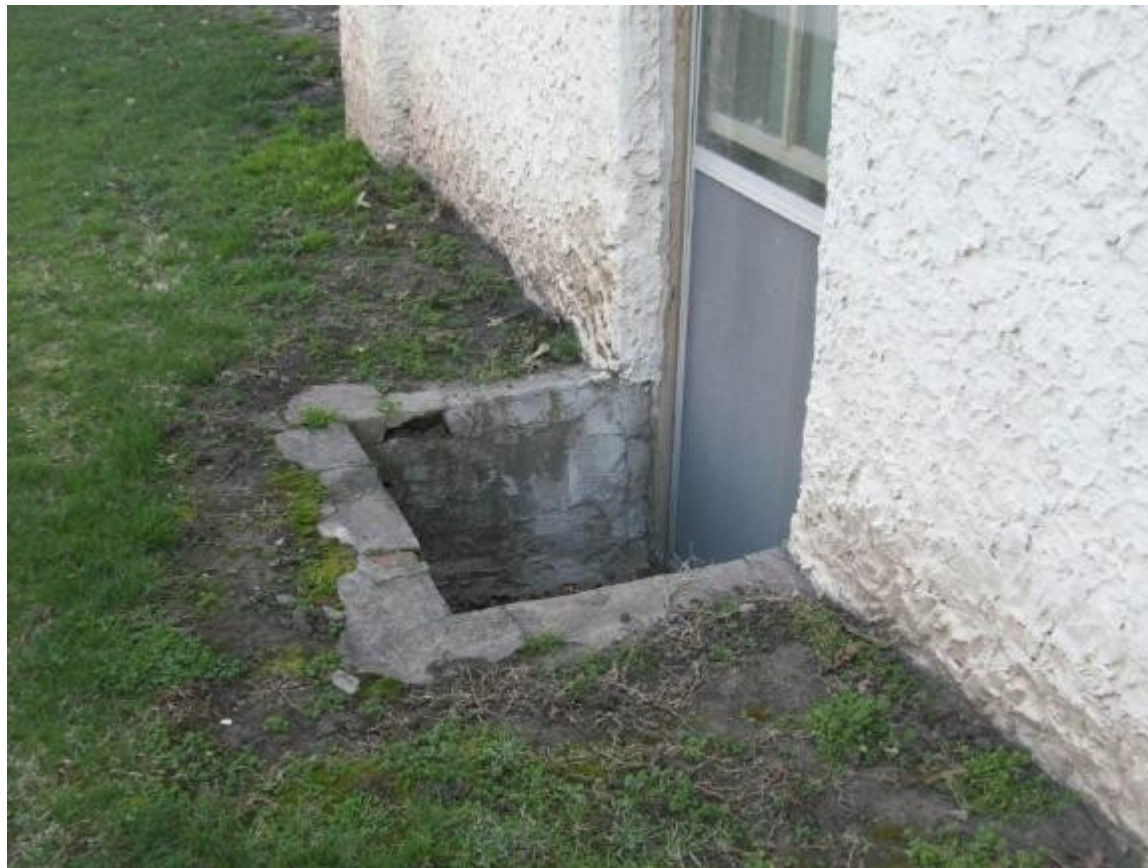
Photo #12

Window Wells Allowing Water Into Basement

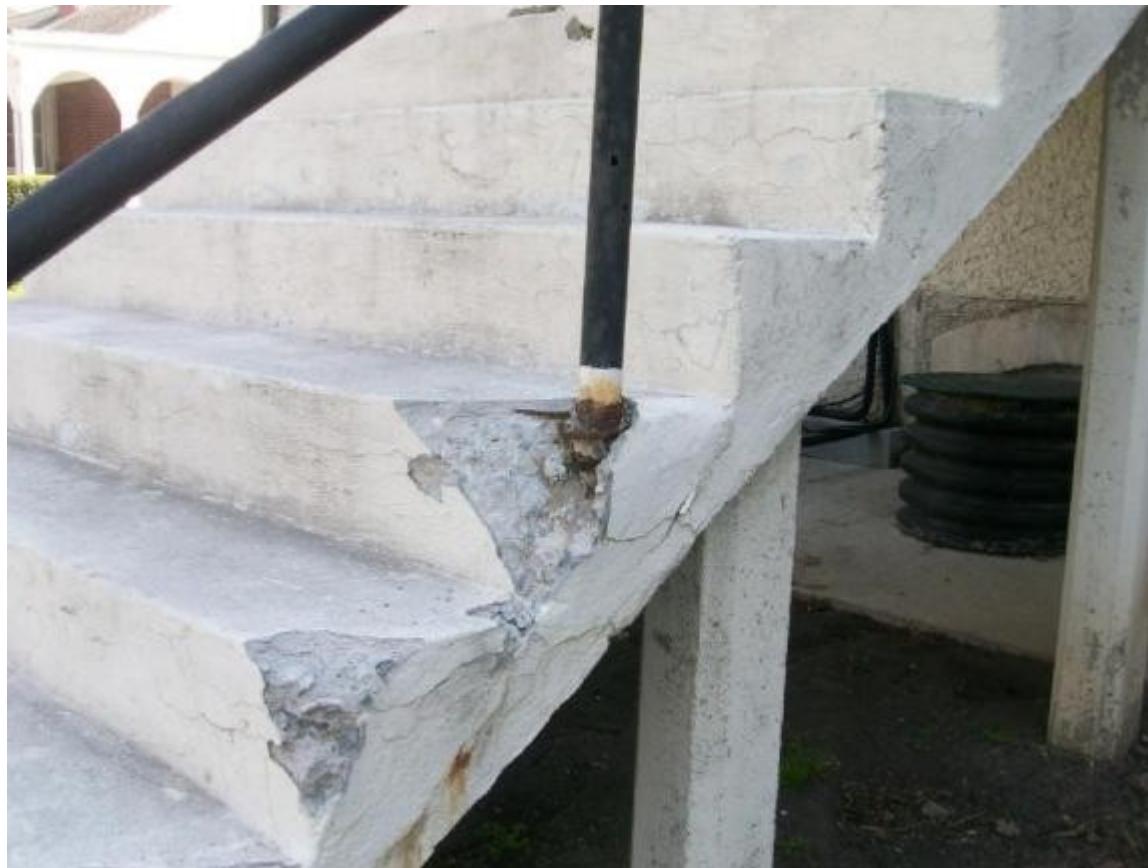
Photo #13

West Stair Deterioration

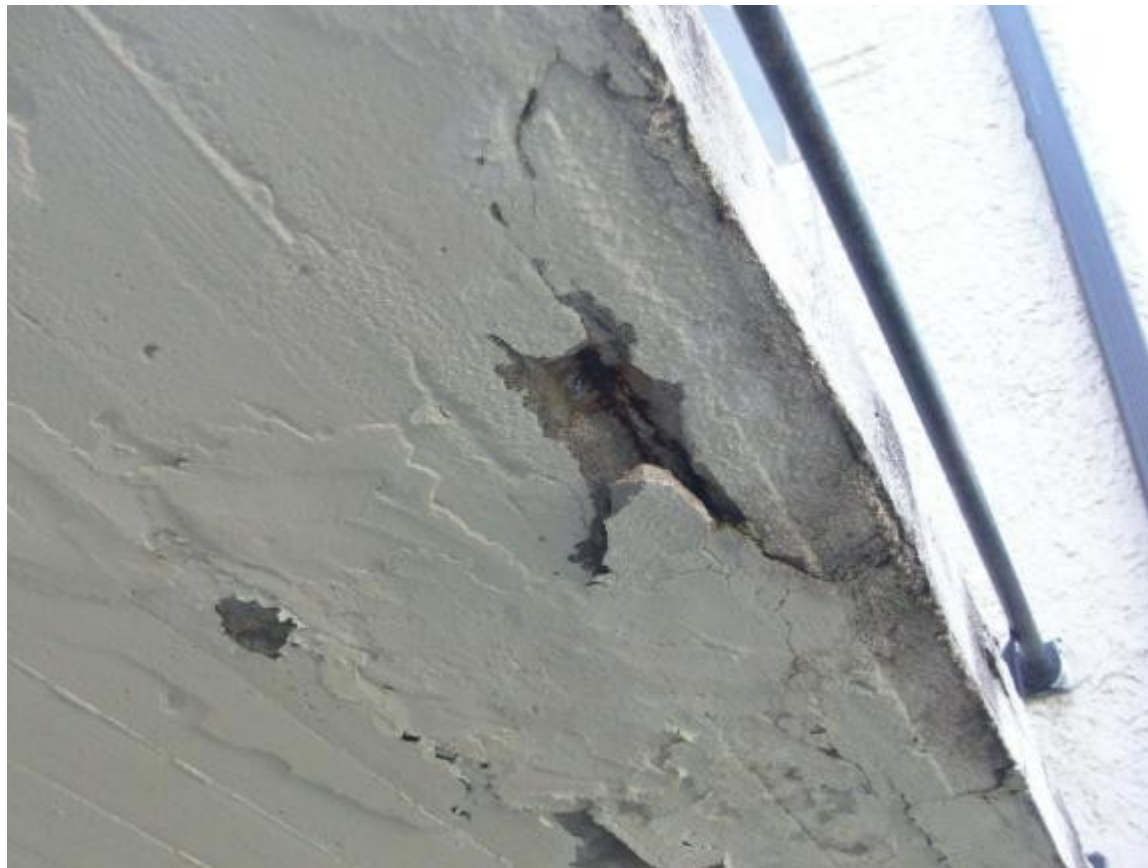
Photo #14

West Slab Deterioration

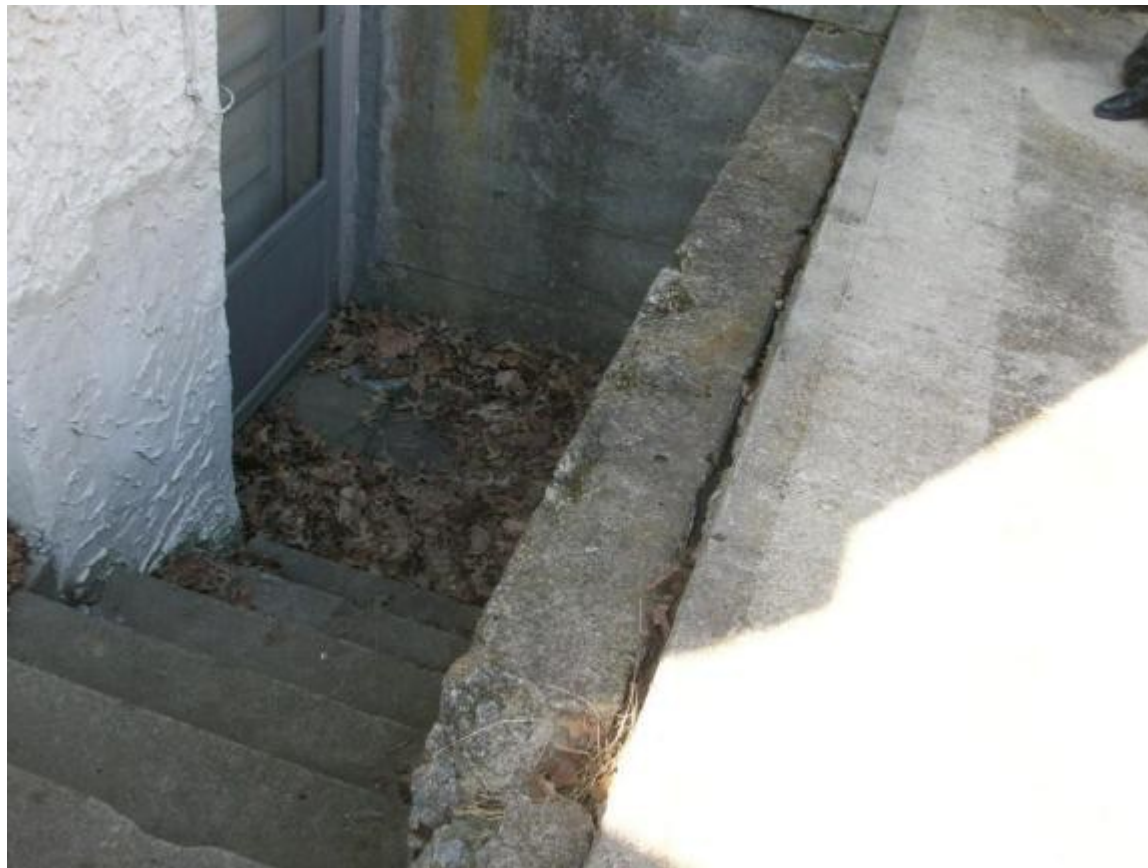
Photo #15

Unfriendly, Non Handicapped Accessible Basement/Kitchen Entrance

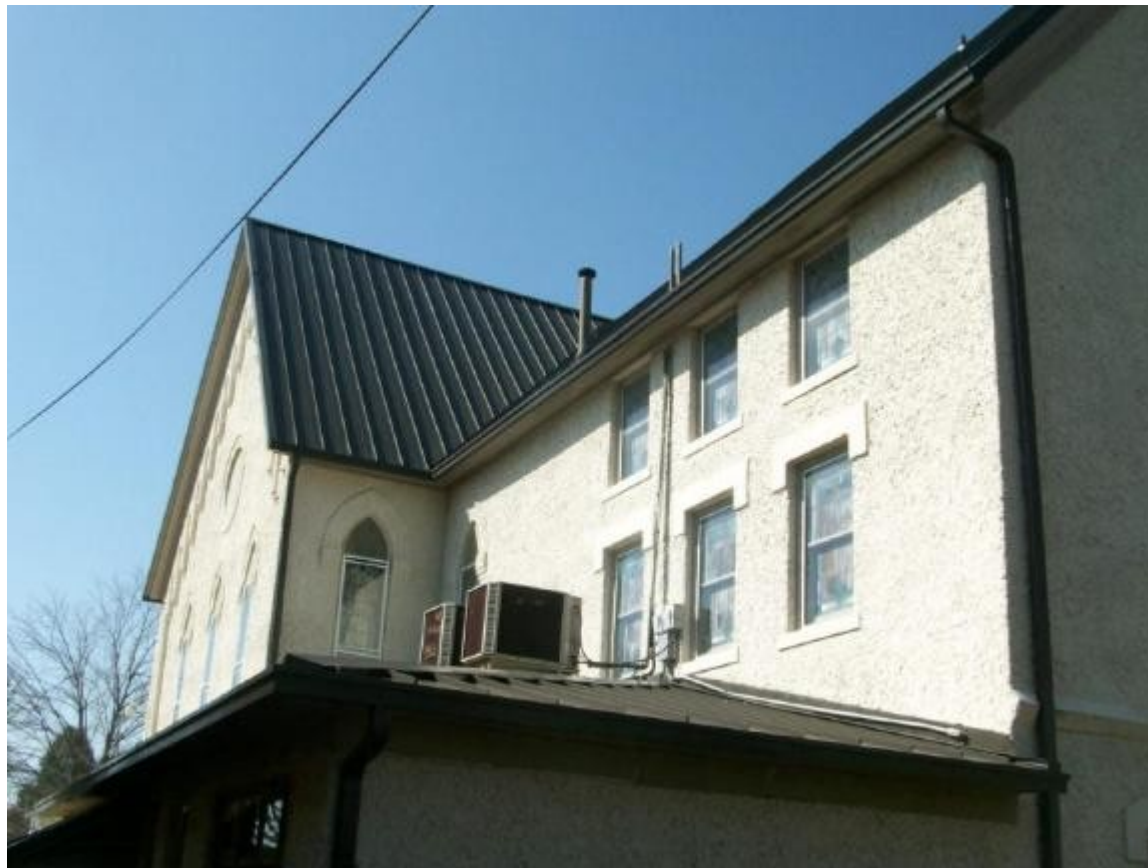
Photo #16

Mechanical Units On Roof Not Easy To Maintain  
Nor Good For Roof Condition

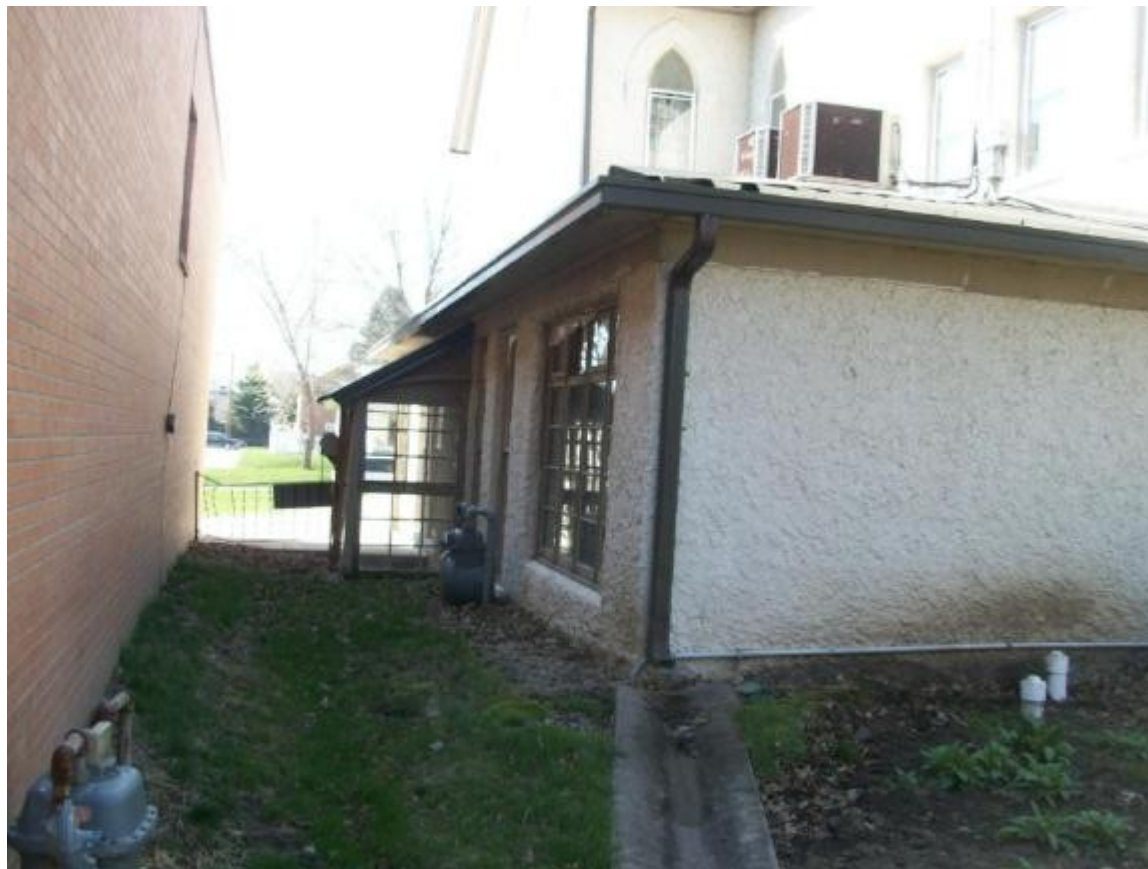
**Photo #17**

**Mold Evidence**

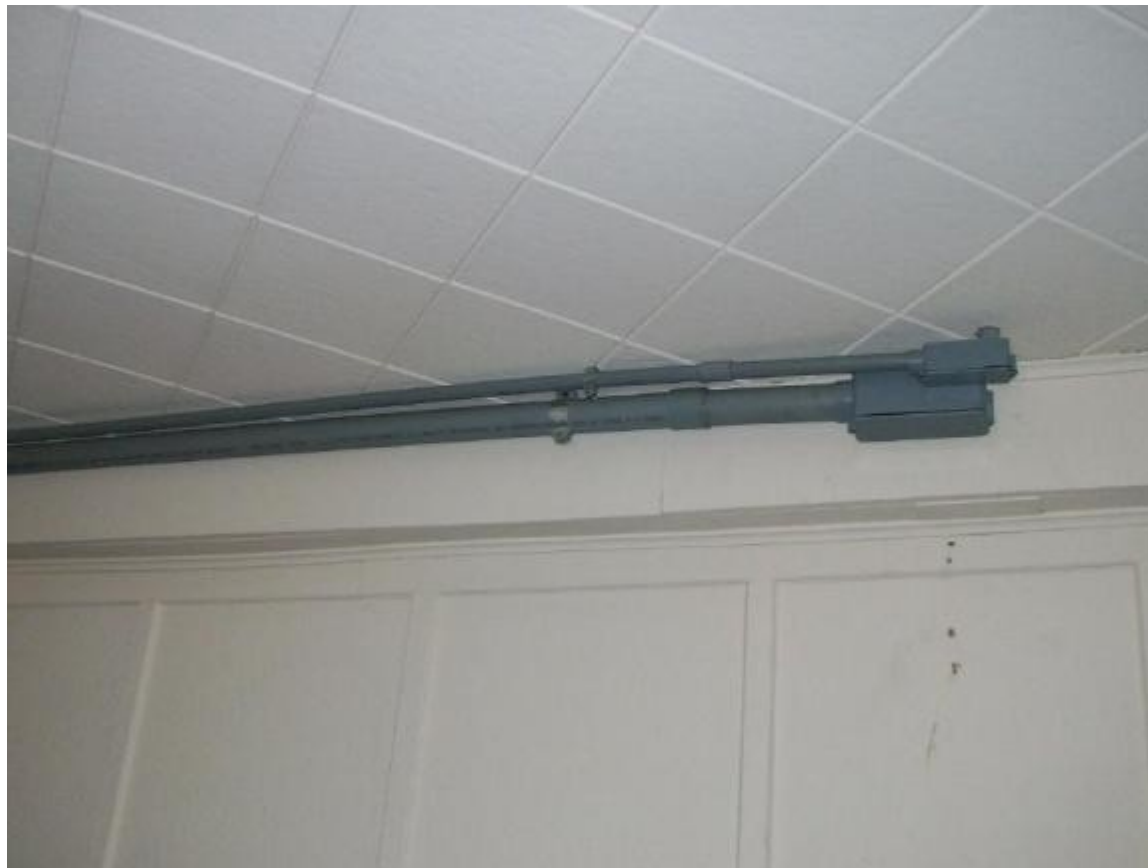
Photo #18  
Visible Conduit Runs

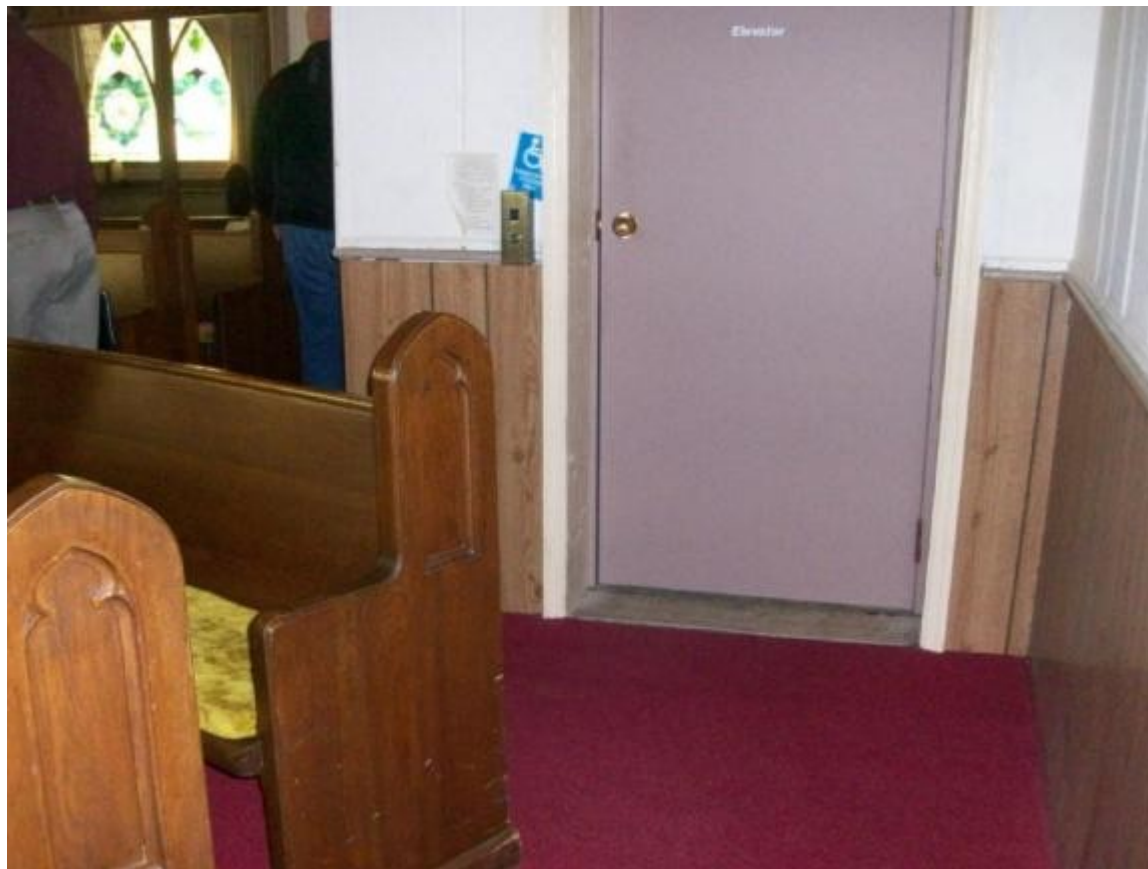
**Photo #19**

**Unfriendly Elevator Access Into Sanctuary**

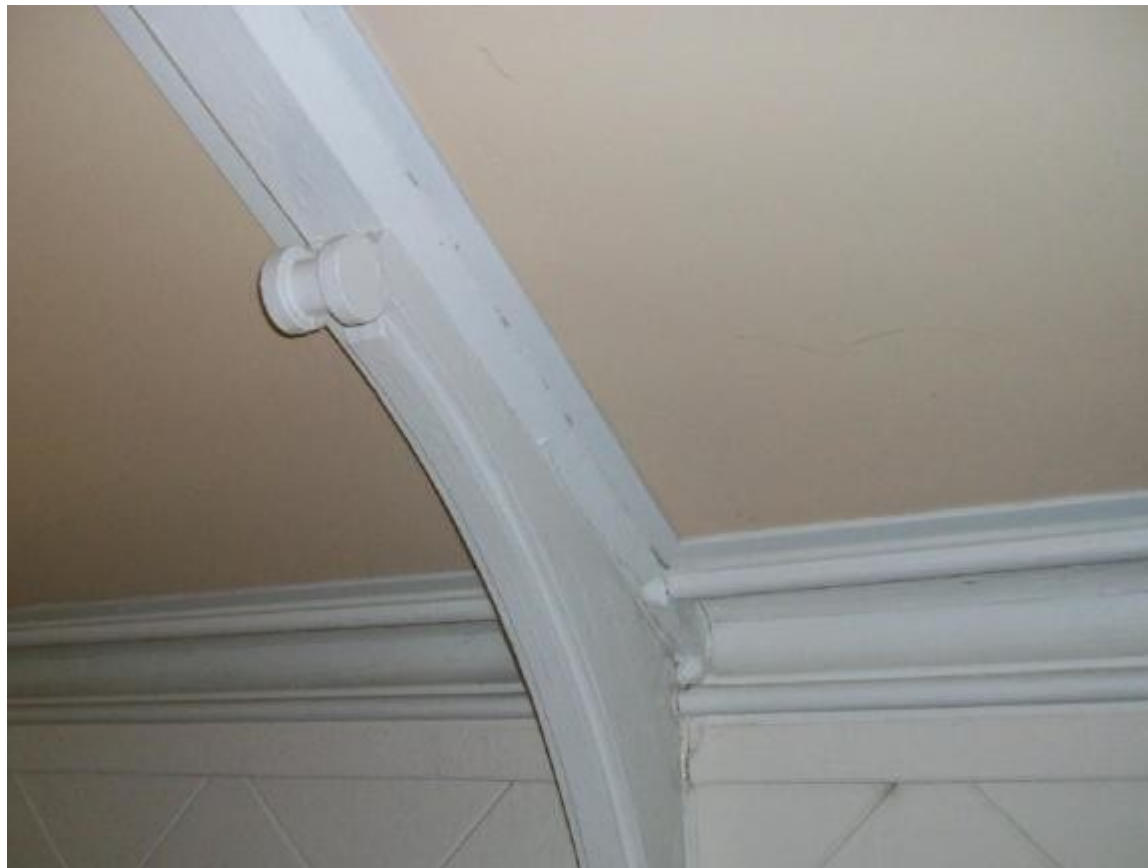
Photo #20

Movement Evidence On Sanctuary Roof Trusses

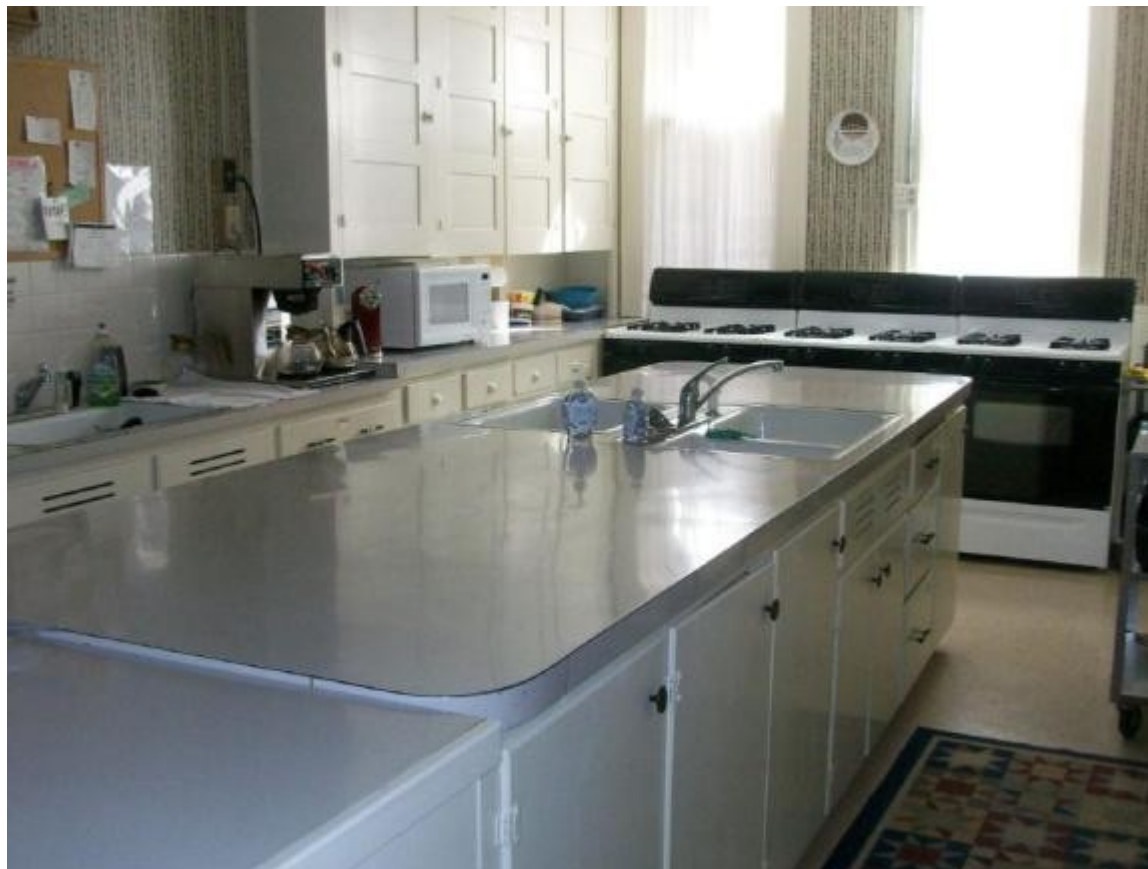
**Photo #22**

**Well Maintained, Outdated, Not Code Compliant Kitchen**

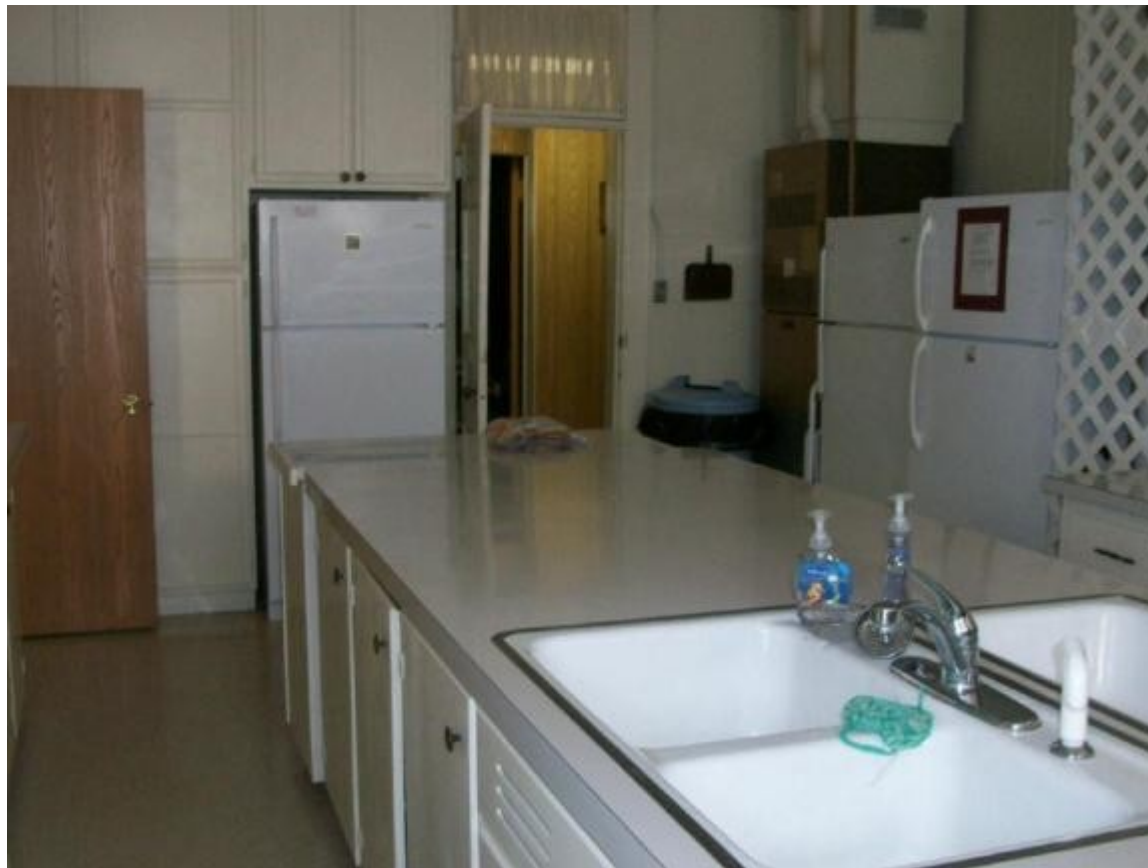
**Photo #23**

**Well Maintained, Outdated, Not Code Compliant Kitchen**

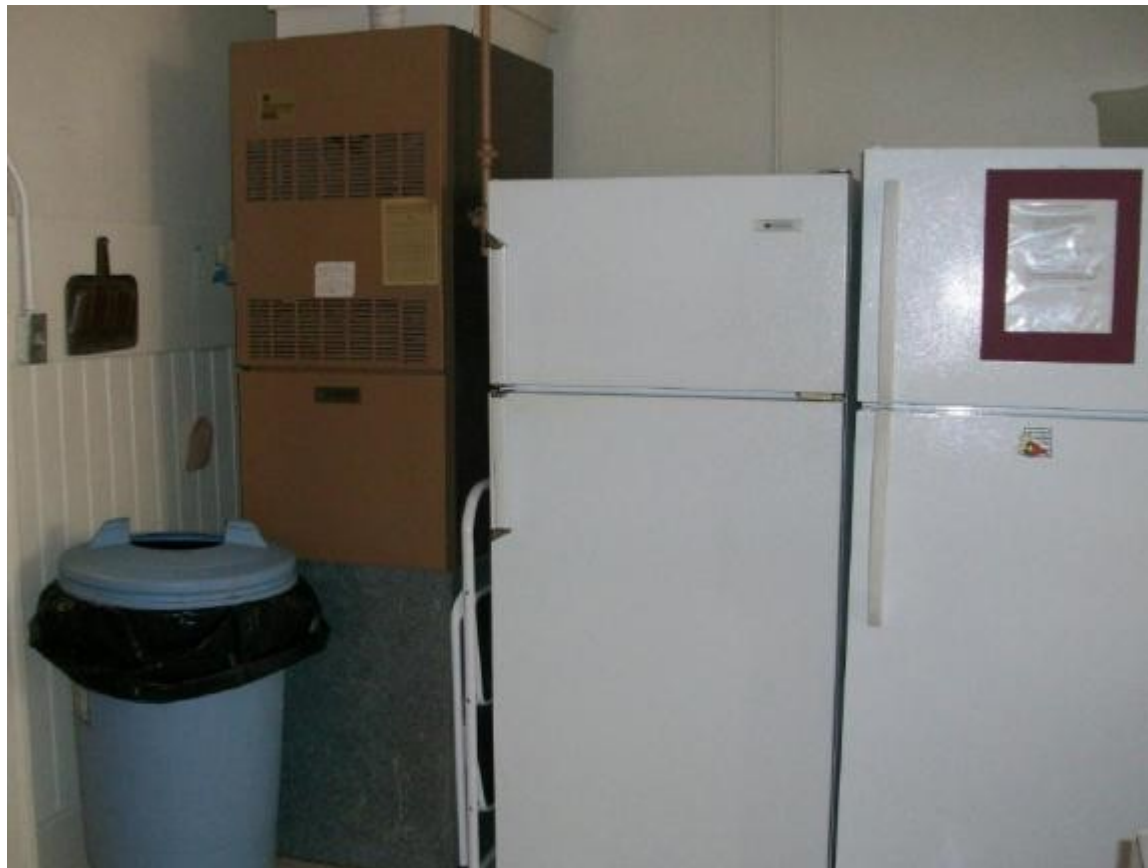
Photo #24

Furnace In Kitchen
