First United Methodist Church  
Clarinda, Iowa

Facilities Improvement Committee  
Congregational Forum & Progress Update  
to Congregation, November 14, 2010

- Walk-thru evaluation conducted April 9, 2010 with Ron Tekippe and Dean Fajen, licensed Engineers from HGM Associates Inc. – Consultant, Council Bluffs, Iowa.
- Purpose: To obtain an un-biased viewpoint that would identify concern areas within the existing Church; to gather information useful for either renovating the existing Church or building a new Church.

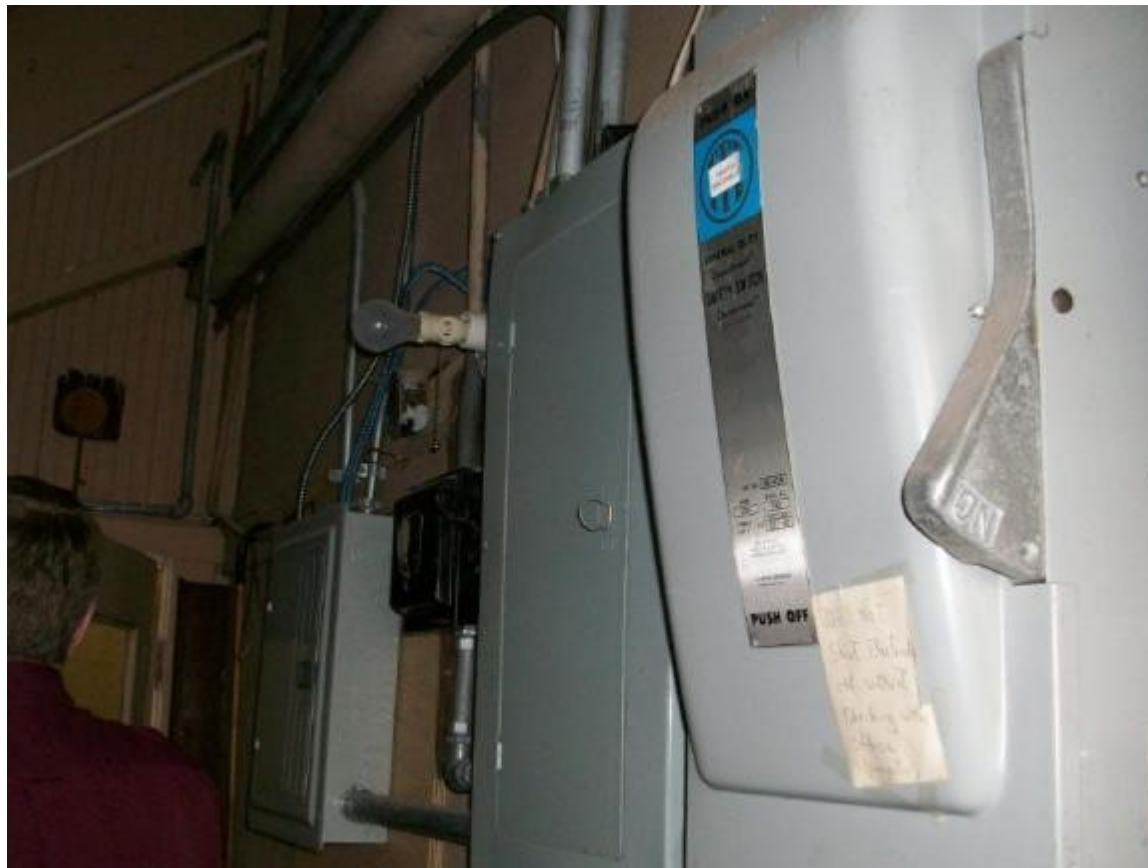
**Photo #25**

**Old Electrical Panels And Gear**
